UNITED STATES DISTRICT COURT SOUTHERN DISTRICT OF TEXAS LAREDO DIVISION

COMPLAINT

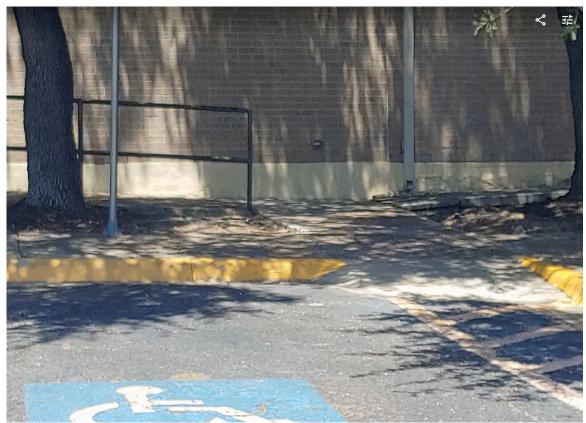
BBVA Compass Bank in Laredo TX. Wide angle view of property. No Van Accessible space near entrance (must have 96" side access aisle, aisle cannot be in path of traffic)
